Late complication of heart stimulation — lead abrasion in pacemaker pocket

Krzysztof Boczar¹, Barbara Małecka^{1,2}, Andrzej Ząbek¹, Kazimierz Haberka¹, Jacek Lelakowski^{1,2}

¹Department of Electrophysiology, John Paul II Hospital in Krakow, Poland

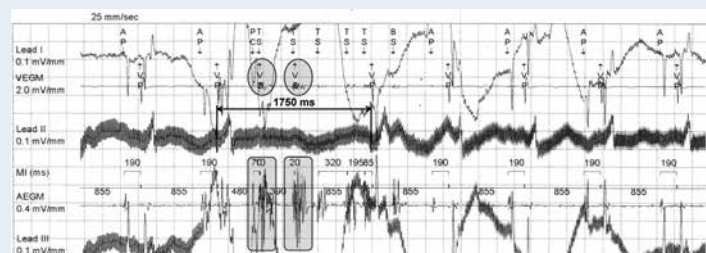
Figure 1. 'Crackles' in ventricular IEGM = VEGM (circles) and in atrial IEGM = AEGM (rectangles), inhibiting pacing for 1750 ms with lack of rhythm — lead II (arrow). Artifacts in leads I and III — wandering of isoelectric line while moving left upper limb

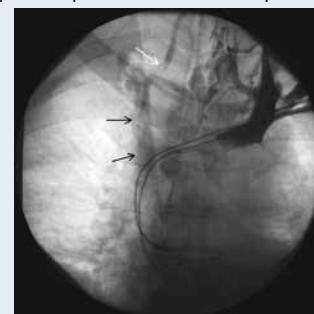
Figure 2. Collateral circulation with the inflow by right brachiocephalic vein (arrows)

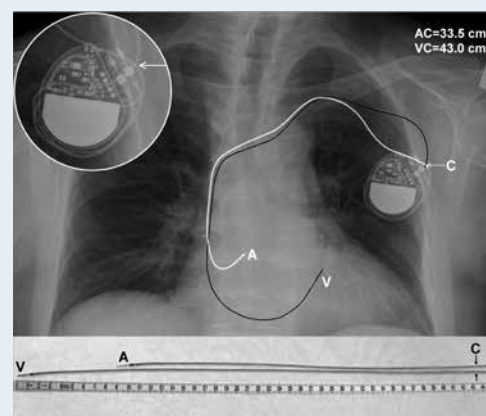
Figure 4. Chest X-ray — postero-anterior projection; A — atrial lead; V — ventricular lead; C — the site of mutual contact of leads in the pocket. In the circle can be seen magnification of the site C
