Spontaneous dislocation of the endocardial lead into the left ventricle through the intraventricular septum

Krzysztof Boczar¹, Monika Komar^{2,3}, Andrzej Ząbek¹, Jacek Lelakowski^{1,3}, Barbara Małecka^{1,3}

¹Department of Electrocardiology, John Paul II Hospital in Krakow, Krakow, Poland

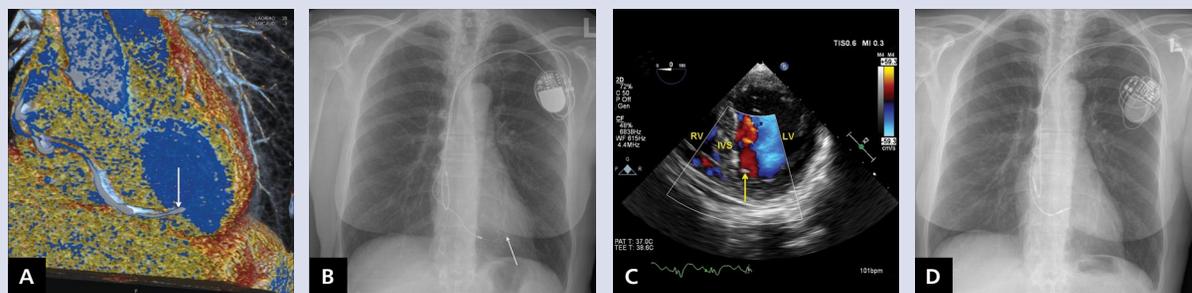
We report a case of a 66-year-old woman with a history of DDD pacemaker implantation in 2005 due to vasovagal syncope and generator change in 2014. The patient was implanted with an atrial lead Biotronik SX 53-JBP positioned in the right atrial appendage and a ventricular lead Biotronik SX 60-BP positioned in the right ventricular apex. A few months after generator change the patient underwent a diagnostic process due to heart palpitations and stabbing pain in the chest. The chest pain occurred during body movements and deep breathing. In electrocardiographic Holter monitoring the sensing disturbances in the ventricular channel were detected. During pacemaker interrogation the electrical parameters of both leads were normal except for an increased number of short V-V intervals. The patient was qualified to transvenous ventricular lead extraction and implantation of a new ventricular lead. In the meantime the patient underwent a computed tomography scan in search of coronary heart disease, and it was found that the ventricular lead was perforating the intraventricular septum on the level of the apical septal segment. The length of the lead in the left ventricle amounted to 7–9 mm (Fig. 1A). The displacement of the lead was suspected also in a chest X-ray of the current location of the lead (Fig. 1B). In transthoracic and transoesophageal echocardiography the thrombus on the lead tip and left-to-right shunt through the septum along the lead were ruled out (Fig. 1C). The decision to extract the ventricular lead transvenously with mechanical systems with surgical backup and transoesophageal echocardiography monitoring was upheld. The procedure was a complete success. There was no residual left-to-right shunt after the extraction of the lead. Subsequently the new ventricular lead was implanted (Fig. 1D). The presented case is an example of a rare and dangerous complication of permanent pacing. The existence of a short portion of ventricular lead inside the left ventricle posed a risk of thrombus formation and peripheral embolisation, of which the most dangerous is stroke. The late perforation of intraventricular septum by a passive fixation lead has not been reported in English-language literature yet. The probable cause of the distant (in time) perforation was the application of excessive force on the tip of the lead during implantation, which was then aggravated by the ingrown lead into the tricuspid valve region. Transvenous extraction of the lead displaced into the left ventricle requires surgical intervention according to the current Heart Rhythm Society (HRS) expert consensus. In this case a less invasive approach was successfully used. However, close attention was directed toward identification and prevention of potential perioperative complications such as left-to-right shunt after lead extraction and arterial embolisation. Furthermore, the procedure was conducted with surgical backup and continuous intraoperative transoesophageal monitoring.

Figure 1. **A.** Computed tomography scan, arrow indicates the tip of ventricular lead in the left ventricle; **B.** Chest X-ray before transvenous lead extraction procedure, arrow indicates displaced tip of the ventricular lead; **C.** Transoesophageal echocardiography with colour Doppler, arrow indicates right ventricular lead in left ventricle (LV); RV — right ventricle; IVS — intraventricular septum; **D.** Chest X-ray after implantation of new DDD pacemaker
