A field survey–based method to characterise landslide development: a case study at the high bluff of the Danube, south-central Hungary

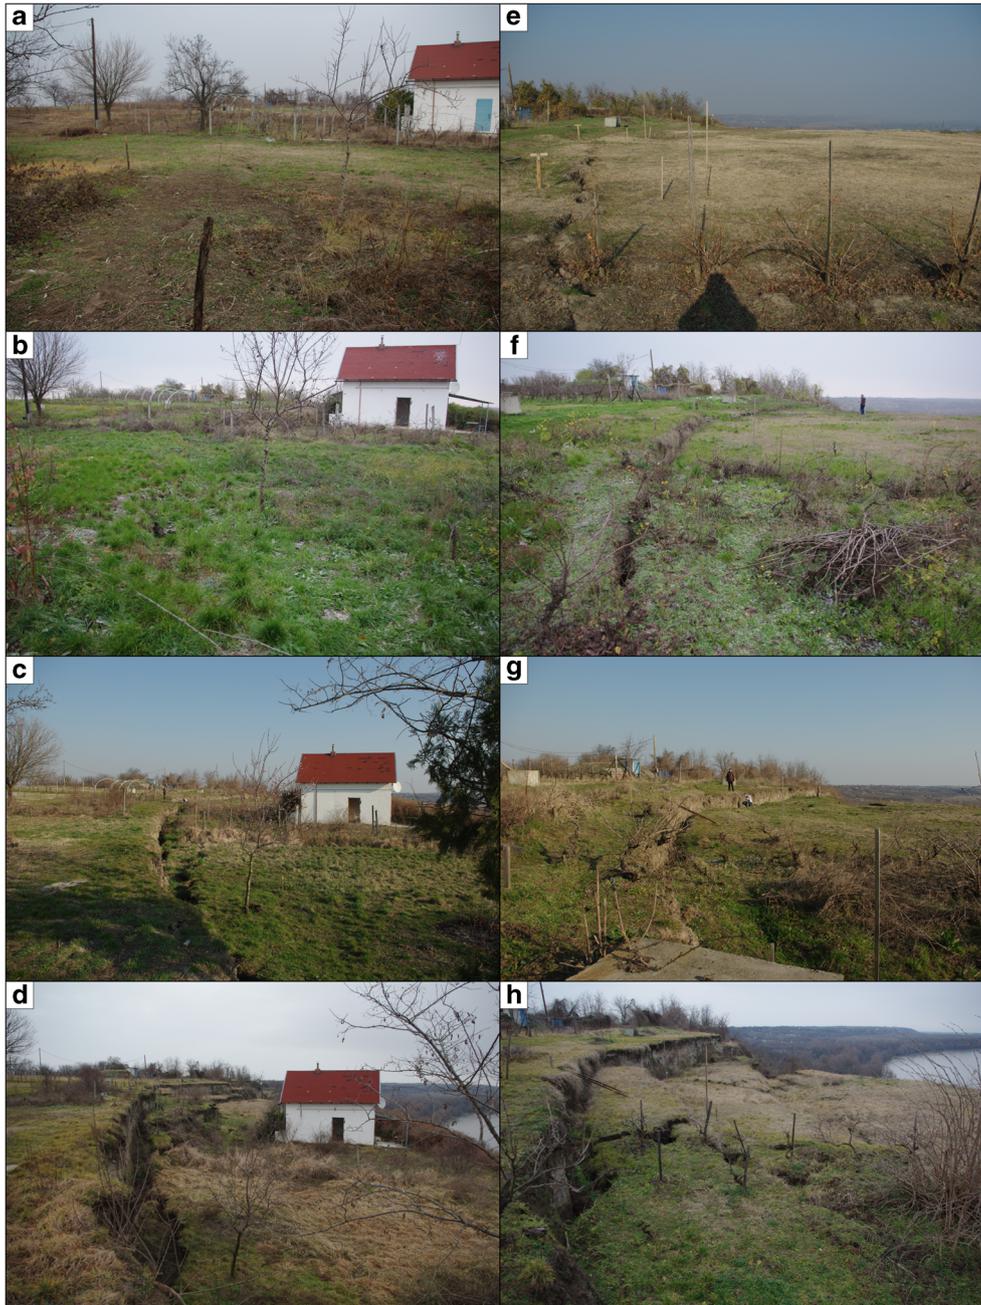
Fig. 5 Displacements, growth cracks and scarp development along the crown of the MB. A–D Southern MB. E–H Northern MB (pictures were taken from the south toward north). A, E = field campaign 1; B, F = field campaign 20; C, D = field campaign 22 (end of campaign period 1); D, H = field campaign 27 (end of campaign period 2)

Horizontal and vertical positions of the MB points have changed in time (2/a, 2/b, 2/c and 3/a, b, c on Fig. 4). Over field campaign subperiod 1, i.e. between days 1 and 788 (field campaign 20), the MB points moved with relatively low velocities, and displacements had clear linear trends. The field campaign subperiod 2 covered campaigns 20 and 22 (day 789 to day 1264), during which displacements have been accelerated and larger-scale movements led to visible surface changes (Fig. 5).

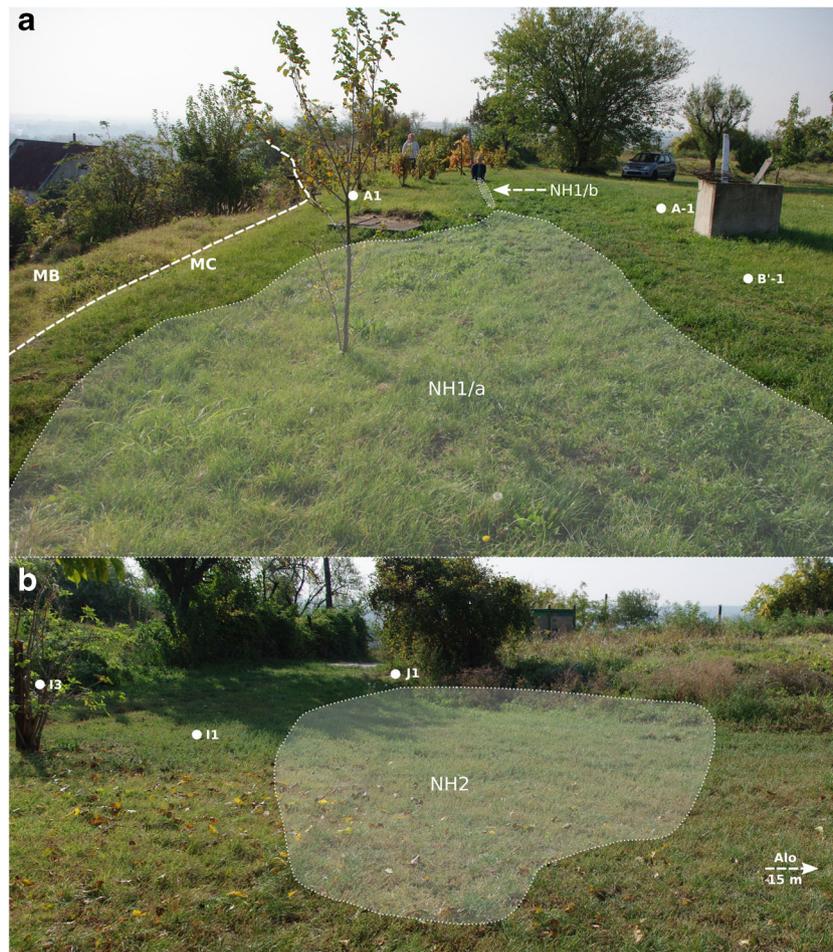
Fig. 11 View of the newly developed (recent) hollows (crown cracks) in October 2018. The hollows are bordered by dotted line. **a** Hollows (NH1/a, NH1/b) on the northern part of BA. **b** Hollow (NH2) on the southern part of BA. MB = moving block; MC = main crack. Further, letters indicate survey point locations. To identify additional geomorphic details of the monitoring network, see Figs. 2b and 5D and H

The appearance of the new shallow hollows is the first visible sign of the displacements of the BA. However, unfortunately, there is no overlap between the point network and the hollows; hence, the connection of the non-normal distribution and hollow development cannot be fully validated. Formerly, we reported two shallow hollows from the research site (Bugya et al. 2011). They were formed on the northern MB almost in parallel with the recent scarp of the landslide (Fig. 13). They were up to 10 cm deep with a diameter of about 2 m. The western one was located among points A3–A5, B'3–B'5, C'3–C'5, D'3–D'5 and E'3–E'5, while the eastern one laid among points A7–A9, B'7–B'9 and C'7–C'9 (point names of the recent paper). Bugya et al. (2011) assumed hollows as the indicators of further displacements and disintegration processes within the MB. The formerly hidden crack of the western hollow (WH) was also partially excavated and identified by Szalai et al. (2014a); however, only a 'supposed crack line' was marked in the axis of the eastern hollow (cf. Fig. 7. in Szalai et al. 2014a). Later, Szalai et al. 2014b marked a 'coherent fracture zone' in the western hollow and fractures on the southern end of the eastern hollow (cf. Fig. 13; P2–P3 profiles in Szalai et al. 2014b). Subsequent minor crack and scarp
