Slope relaxation following landslides in the Łososina River Basin, Beskid Wyspowy Mts., Poland

Elżbieta Gorczyca

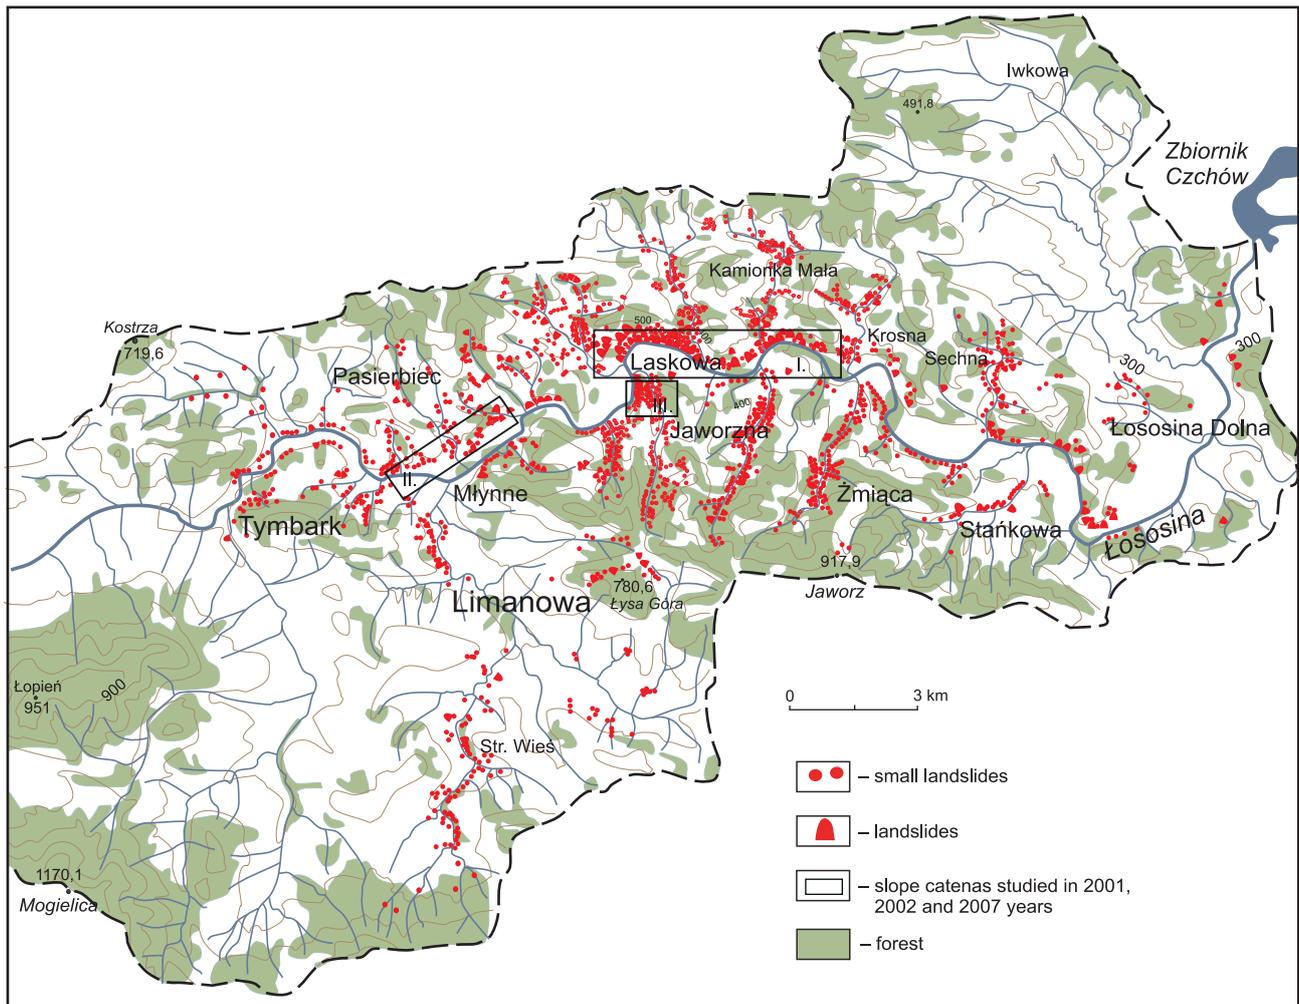
Fig. 1. Location of landslides developed or activated during 1997–2000 in Łososina basin

The most powerful of the three events – the rainfall of June of 1997 – produced 1,340 landslides, mudflows, and creeps on the slopes of the Łososina basin (Fig. 1). A research study conducted at the time produced a map featuring 1,193 new landslide forms covering a combined area of 254,391 m². The mapping process also covered 147 old landslides and creeps with a combined area of 7,774,121 m². This included 89 creeps that had become partially reacti-

The main study method presented in this paper is the mapping of slide forms. Indeed, geomorphological mapping followed every mass movement that had occurred in the study area from 1997 to 2000. The landforms mapped in 1997 were observed again in 1998, 1999, and 2000. Photographs of the landslides were taken and drawings sketched. The condition and size of the mapped landforms were referenced to landmarks in their vicinity as well as other reference points including trees, poles, buildings, and roads. The fieldwork allowed for the observation of morphological changes over time. This phase of extensive research was followed by assessments in 2001, 2002, and 2007. The purpose of each assessment was to examine the degree of degradation of the landslide forms in the three selected slope zones by looking at the degree of overgrowth, the thickness of colluvia, the shape of the colluvial toe, and the “freshness” of the landslide scar. The three slope zones were selected for study purposes because of their degree of transformation by sliding processes and the diversity of types of landslides present (Fig. 1).

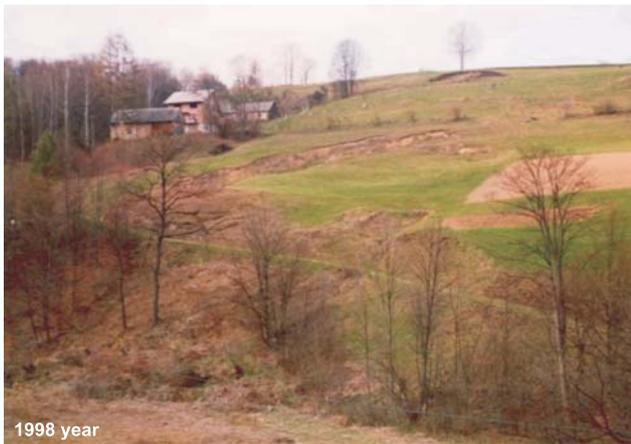
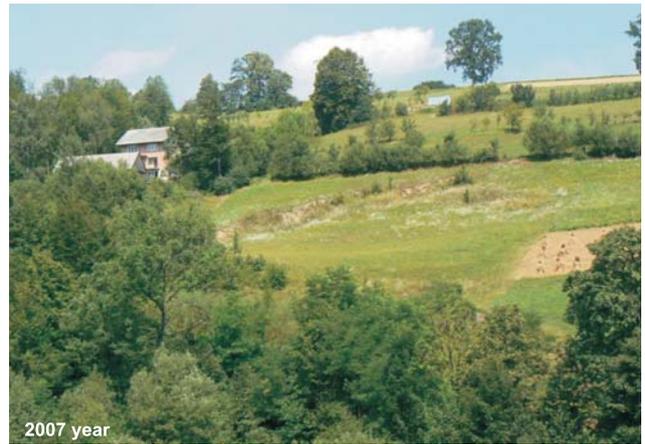
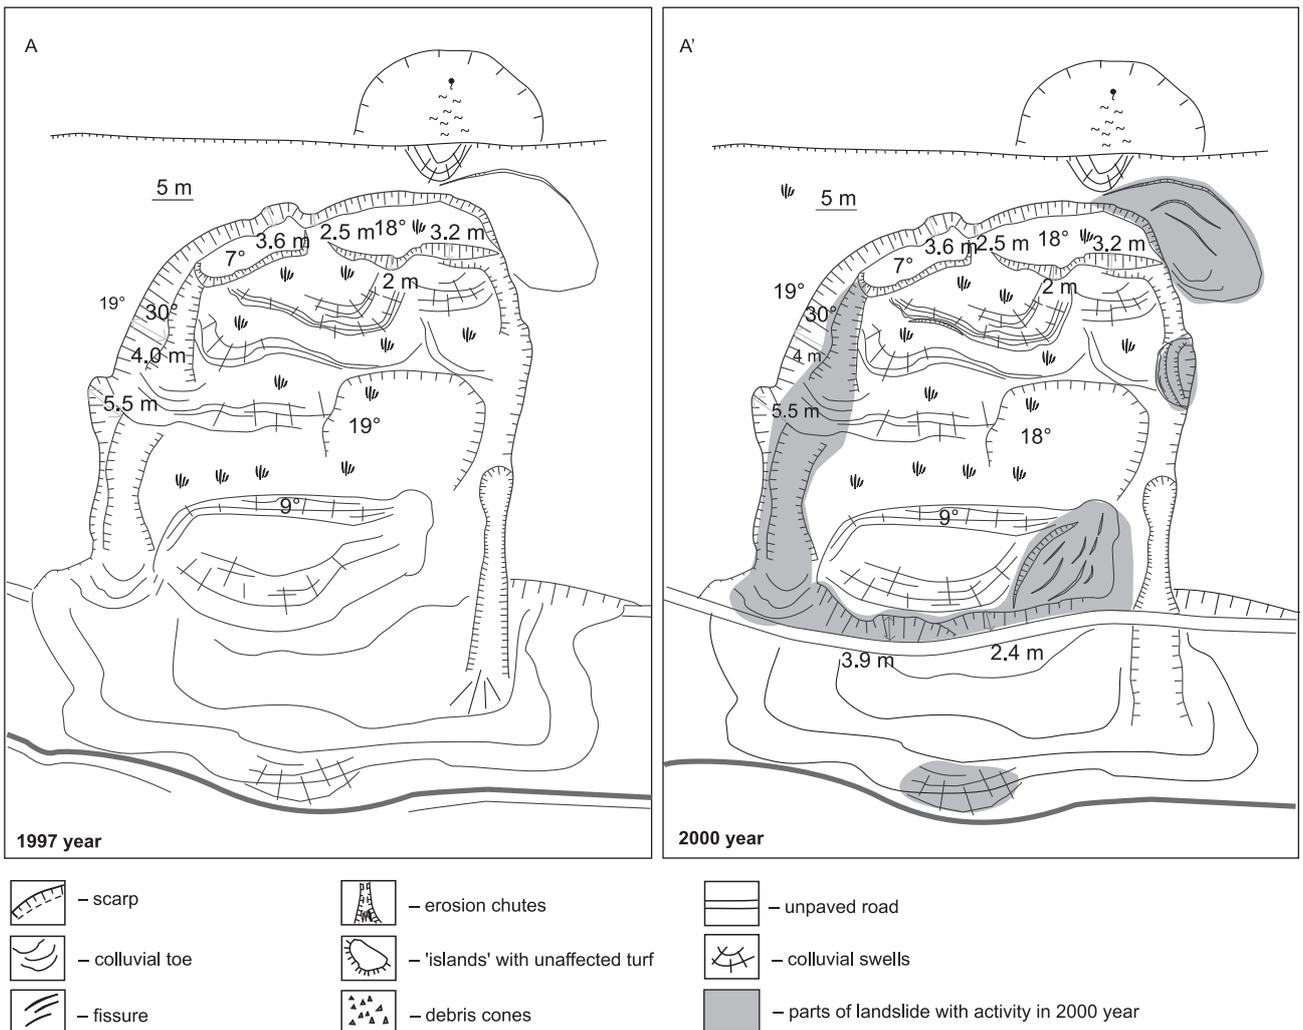
Fig. 2. A rotational slide on the slopes of the village of Mlynne (form no. 966); A – map of the slide produced in 1997 immediately after it had occurred and before human intervention; A' – map of the same slide produced in 2000

Large rotational slides, on the other hand, featured much more development (12% of forms in 2000) and accounted for the greatest share of secondary movements (16% of forms in 2000) of all the landforms studied (Fig. 2). This was largely the result of the lack of stability of the displaced colluvia, which led to their secondary displacement during the study period. The difference between the frequency of secondary mass movements of these types of landforms and the mean frequency of such movements in subsequent years was large enough that its statistical significance was at 0.05.

with a very high rate of colluvia liquefaction (Fig. 5). The effect is either a result of cutting into colluvial swells or toes or the result of removing their support during remedial action such as the rebuilding of a damaged road (Fig. 2).

Towards the end of the research project, three years after the commencement of mass movements, most of the landforms of interest were still highly visible (Fig. 2). Scar edges were still clearly visible and scars were not filled with washed-in material. No systematic surface drainage was discovered within the landforms studied despite the presence of numerous erosion dissections. Three years, however, is too short a period of time to analyze the path to full stabiliza-

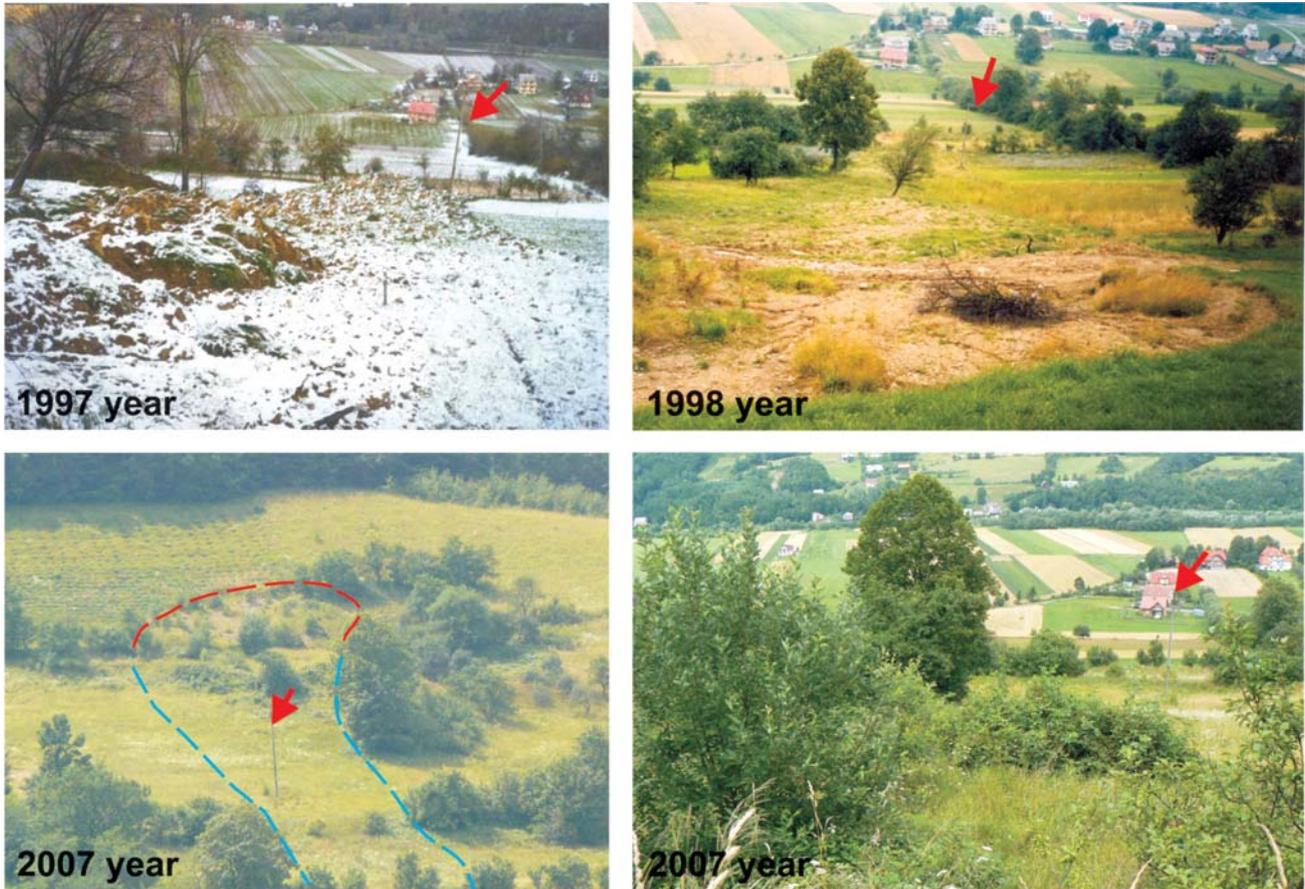
Fig. 3. Flow-slides (village of Laskowa, form no. 597); photos show the course of degradation of the toe section; the red arrow points to a reference point, a power line pole

complex land features such as flow slides and slump-earth flows (Fig. 3). Water pressure in the waste-mantle is presumably so strong that groundwater bursts through, violently turning an initial slide into a more complex movement type. The resulting landforms are characterized by poorly defined slide surfaces, uneven scar surfaces, and very long distances covered by the displaced material.

pact (3) reached a peak in 1997. Types of slope development 5 and 6 were found to have the greatest influence on the development of slide-affected slopes. Their percentage share was the result of initial slope instability following the major rainfall event of 1997 combined with the effects of subsequent rainfall events in 1998 and 2000. The rainfall event of 2000 may help explain the increase in the share of these two type of slope development. During the second phase of research, it was discovered that secondary mass movements had occurred mainly within large old slides that had become reactivated in 1997. Small and shallow slide forms started to overgrow rapidly and blended into the surrounding landscape via the masking effect produced by vegetation and the rapid degradation of their toe sections and scar edges (Fig. 3).

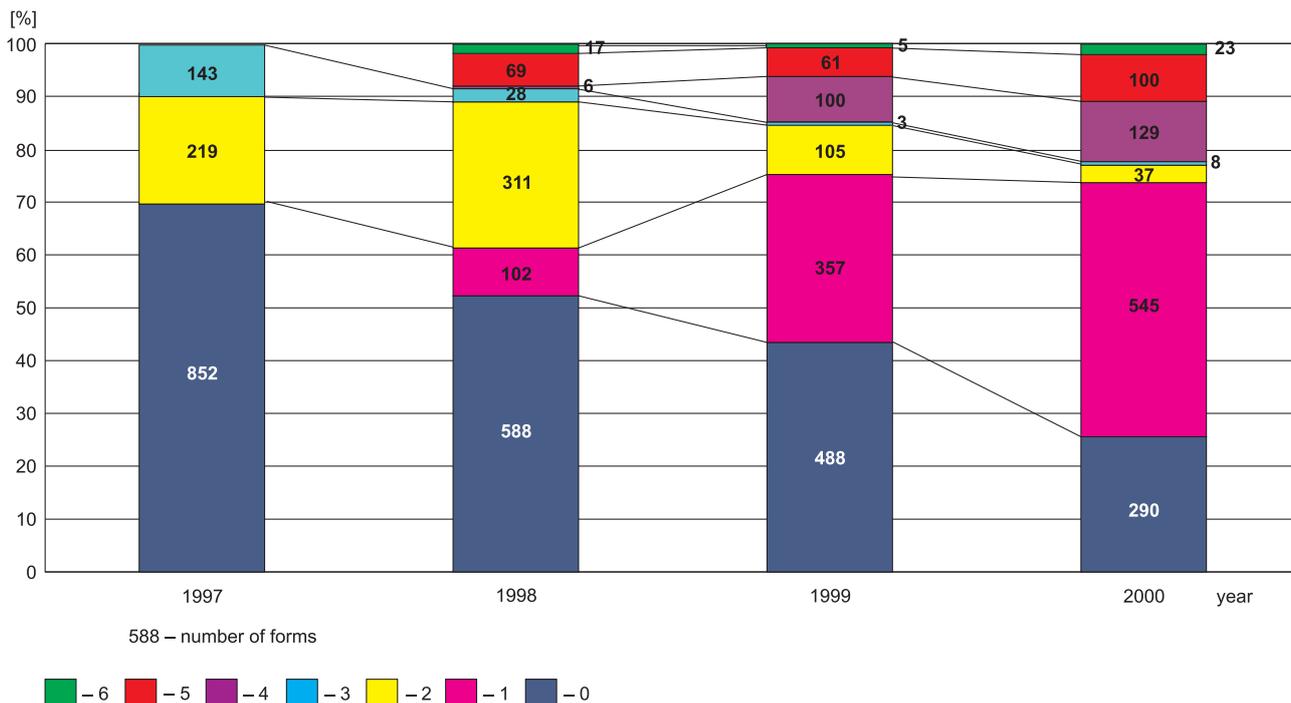
Fig. 4. Share of slope development types (“0” to “6”; see text for detailed legend) during the period 1997–2000

Slope relaxation was measured by assessing the share that each type of slope development had contributed to total change (Fig. 4). The first type of slope development, “0” (no change), which provides an indirect indication of the permanence of the given landform in the slope system, declined from 70% in 1997 to 27% in 2000. Three years after their original development, 73% of landforms had undergone at least some change. A reverse pattern is apparent with regard to vegetation overgrowth (1), which had increased every year to affect approximately 50% of landforms in 2000 (Fig. 4). The most powerful set of processes responsible for the degradation of the toe sections of the slides (2) peaked at 28% of all landforms one year after their development. From that point on, the type of slope development subsided gradually (only 37 landforms in 2000). Human im-

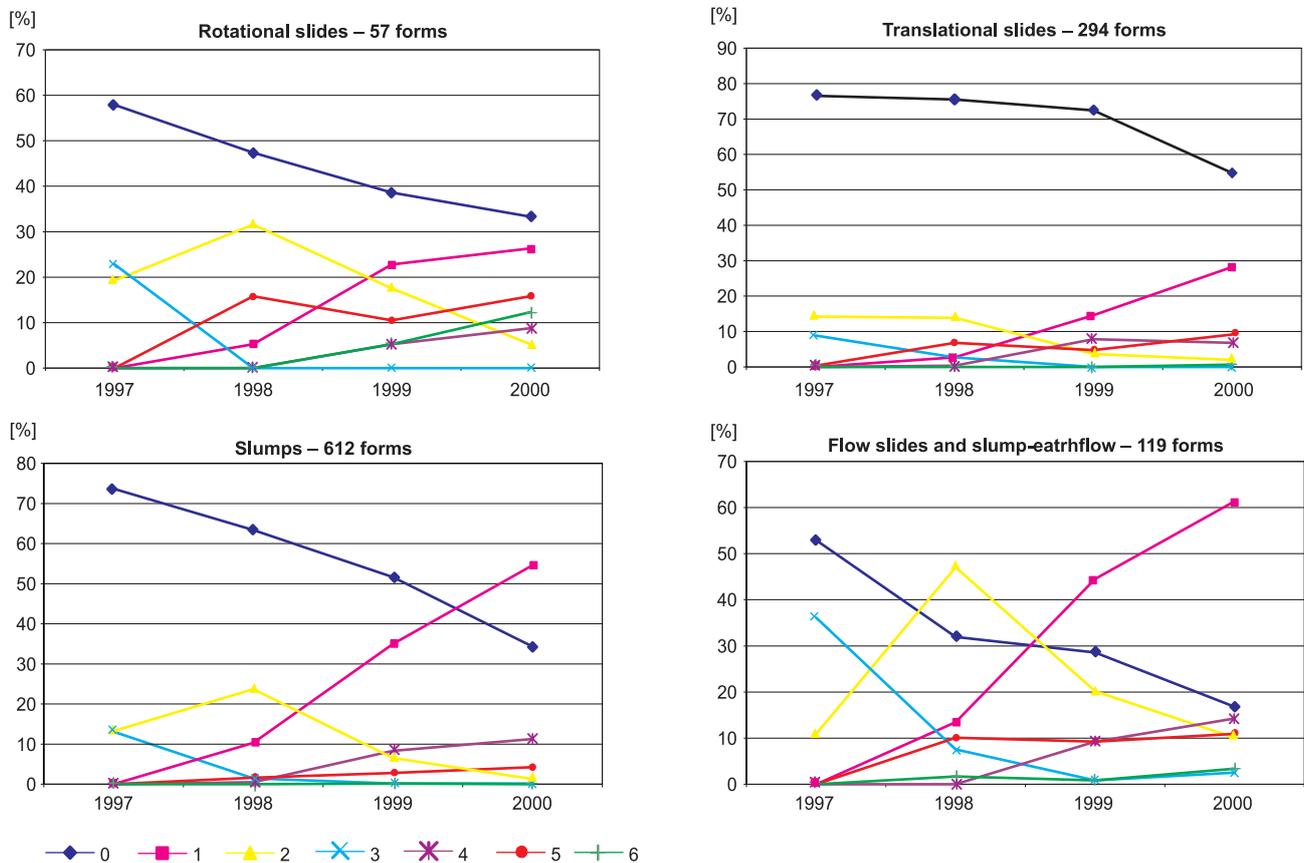
Fig. 5. Share of slope development types for the four landform types during the period 1997–2000 (“0” to “6”; see text for detailed legend)

Slides with a concave slip surface were the most numerous landform type in the study. Small rotational slides accounted for the vast majority of them at 612, while rotational slides were far less frequent at 57. The two landform types differ in terms of their predominant development types (Fig. 5).

Small rotational slides with their relatively small surface area and colluvia deposited in-situ were subject to intense degradation of scar edges (Fig. 5). The most characteristic feature of the slumps was how quickly they became overgrown with vegetation (55% in 2000). As a result of this rapid overgrowth and intense degradation of colluvial toes and scar edges, slumps were the least visible of landforms as early as four years after their initial development. Six

Translational slides (294 forms) were the most stable landform type investigated (Fig. 5). This landform type featured the largest share of forms that displayed no signs of significant change during the four-year study period (55% of forms in 2000). The difference between the percentage of unchanged translational slides and the percentage of this type of slope development in the total number
